# FORT BEND COUNTY HISTORICAL COMMISSION

Project: **FBC Courthouse Renovation 2014**

Comments The history of the Fort Bend County Courthouse,  
401 Jackson Street, Richmond, Texas, and the  
renovation completed in January 2014

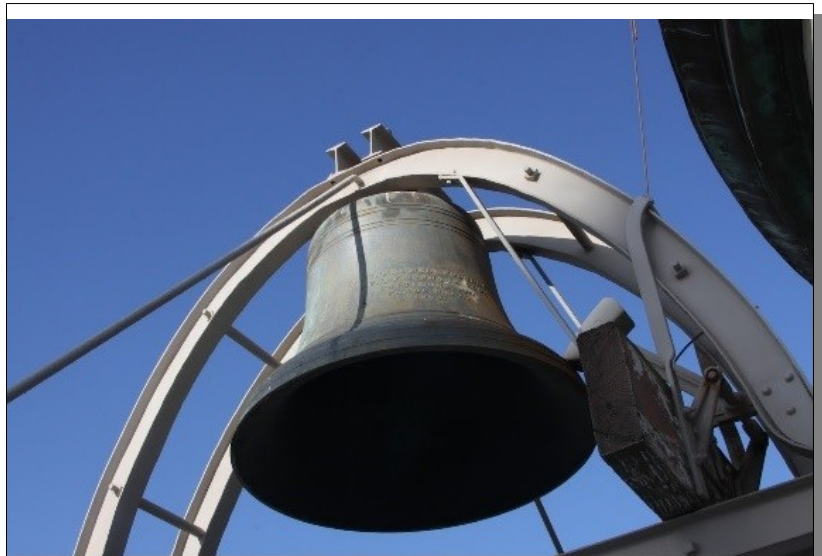
Clock: The bell's gantry support has been sandblasted and repainted. We took the foam system off that vertical armature that you see is now sleeved so that we have protected it from the weather. The armature goes inside the dome to the clock mechanism. On the hour and half-hour the armature swings the hammer to strike the bell.

*FBC Courthouse clock bell is mounted on the roof of the historic building and rings on the hour and half-hour.*

The clock faces are wood and have been resurfaced. The wood numerals on the clock face have been re-cut and repainted and the hands have been replaced. They were rotted and failing. The clock mechanism was sent to Southwestern Clock and Museum near Austin to be restored. It cost much more to repair it than it initially cost to buy: about \$16,000 to repair the clock mechanism.

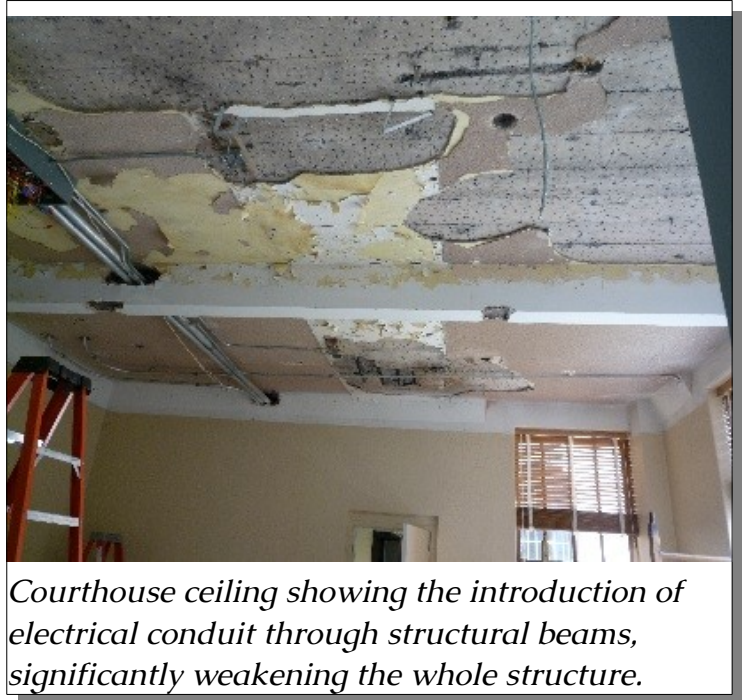
When window A/C units were replaced by central air conditioning, a lot of the damage to the building resulted from the installation of air ducts. They ran conduit or duct work through a structural beam instead of going around the beam. That weakened the whole structure. We feel very fortunate to have conducted this rehab when we did. The building was in pretty bad shape. It wouldn't have been long before it would have been seriously damaged and much more expensive to repair.

*Courthouse ceiling showing the introduction of electrical conduit through structural beams, significantly weakening the whole structure.*

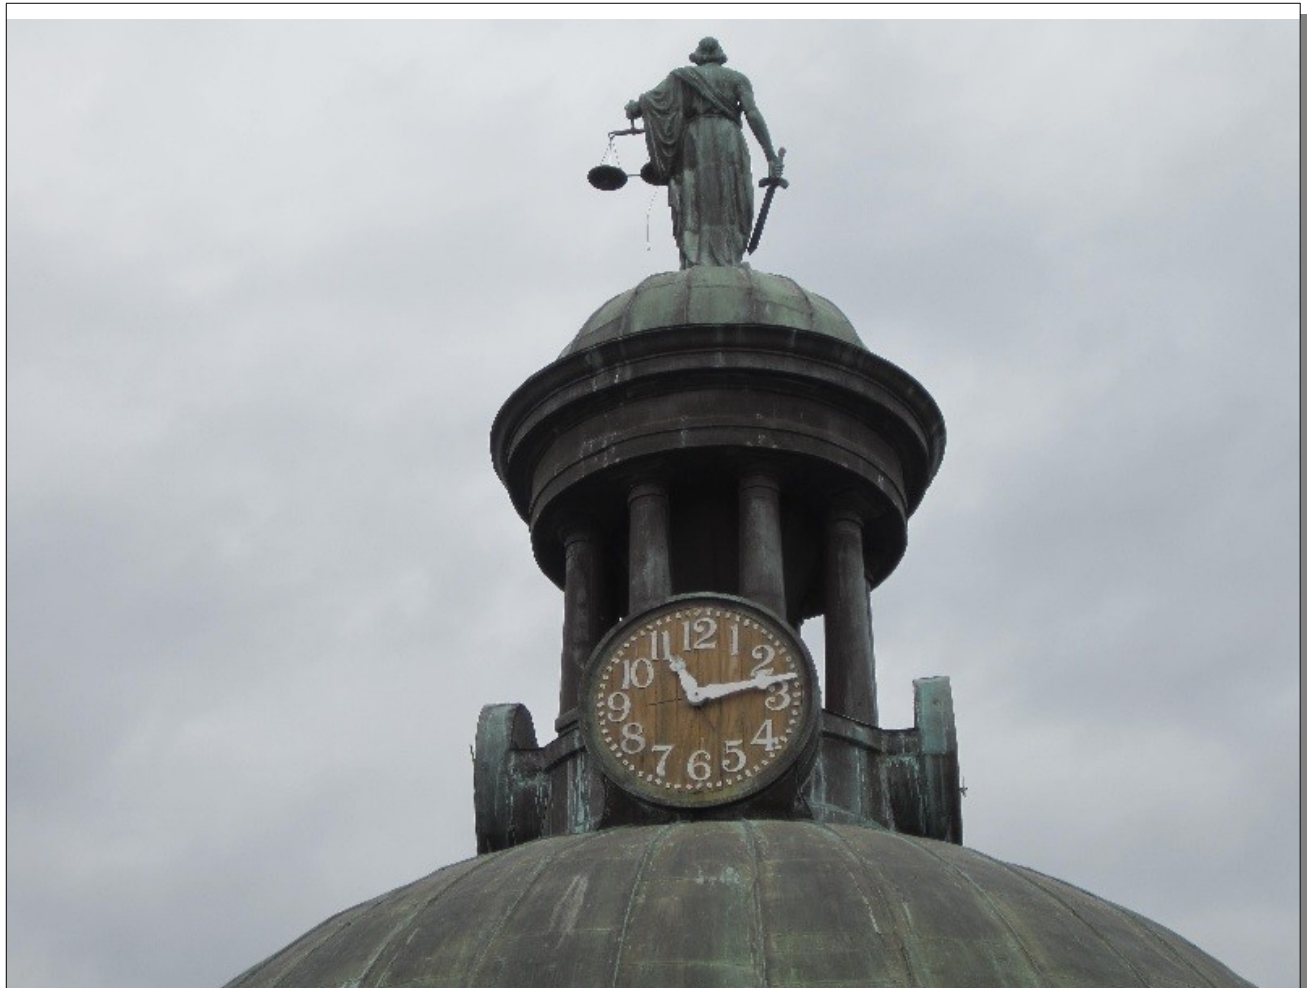
*Statue of Lady Liberty above the historic Fort Bend County courthouse dome and showing the clock.*

**Statue of Lady Liberty:** About three years ago we repaired the statue of Lady Liberty and put new chains on her scale balance. We expect that she's going to last quite awhile. She is also acting as a lightning rod. You can see the wires running around the top of the parapet wall were added to protect the building. It had no lightning protection before.

Since she is the high point, we've attached some of the wires to the frame that supports her. So she'll be saved as well.

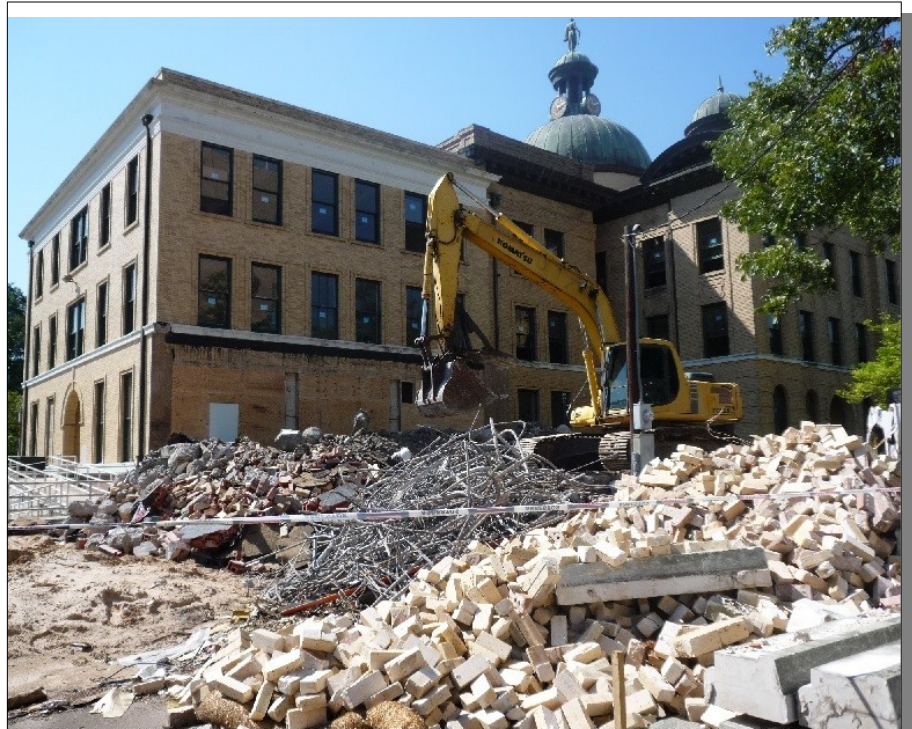
What we found when we got up here was that the original roof was coated with coal tar. In the heat, coal tar softens and flows. So, in time it flowed to the roof drains and plugged them off. The copper downspouts that you see were not just decorative, but they weren't functional because they were all plugged up with debris and coal tar.

*Rubble from the courthouse renovation. Much of the 1952 renovated coal tar roof softened in the heat and plugged drains on the roof. When rain water over-topped the flashing it drained into the building behind the parapet walls.*

When the rainwater couldn't drain off the roof and reached a certain depth it would over-top the flashing and drain into the building from behind the parapet walls. So we cleaned all of that out and installed overflow scuppers so that if the roof drains were ever to become plugged again, the flow would be to the outside of the building not inside. We've also installed the roofing foam system up the sides of the parapet walls so that we could get up to that level before there would be any contact with the masonry.

BRADY: Yes, as opposed to the three inches of drain width that was up there originally, we enlarged the roof drains. We get much more rapid runoff from the roof of the building than we had before and the drains don't so easily plug. You can see all the copper work. It was quite intricate.

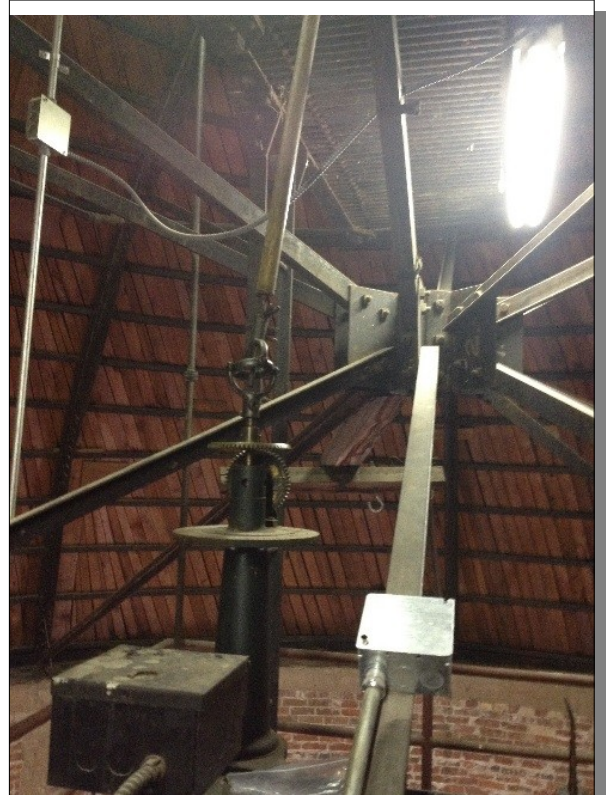
**Inside the Dome:** Do you see the iron framework that establishes the dome's profile? Long leaf pine boards, over which the dome's exterior copper sheets are installed, cover that frame.

This is all original brickwork on the lower section of the dome. The riveted iron struts and supports above the brick portion are covered with long leaf pine staves and the copper sheeting is hammered and attached over that.

*Interior of the FBC courthouse dome showing the profile framework.*

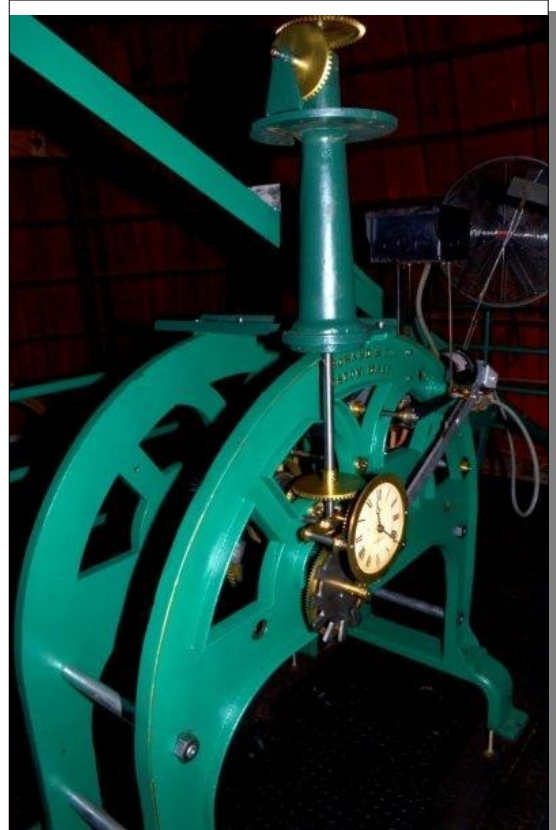
Originally, the clock was driven by weights, like a Grandfather Clock, and you can see some of the original hardware mounted on the opposing wall. It has some historical significance. We might mount a camera on the platform and display it in first floor of the rotunda so people can see the working mechanism. It is really quite a jewel to see. We have some pictures of what it looked like to begin with.

*Courthouse clock mechanism inside the dome.*

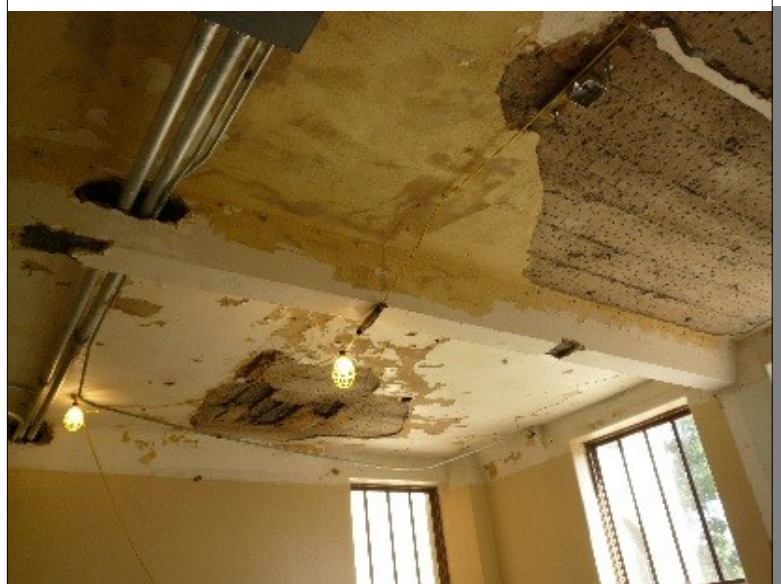
These were some of the beams that I was talking about. Instead of bending around the beam, they just went right through so it had significantly weakened its intended support purpose.

*Basement ceiling showing conduit punched through structural beams and barred windows with bars.*

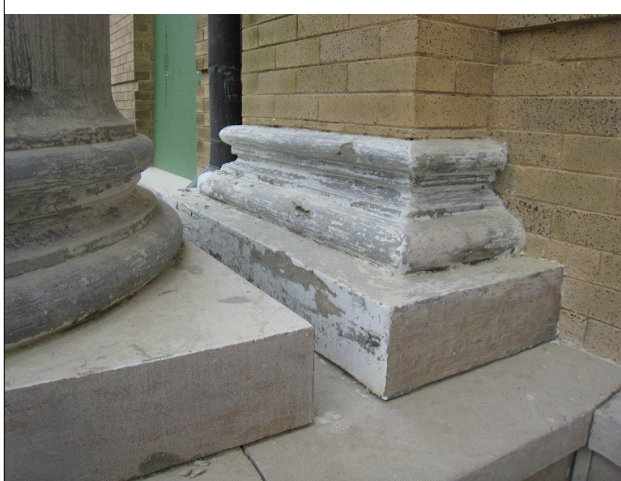
*Damaging paint was removed from the carved cornice using a special blasting media that wouldn't attack the stone.*

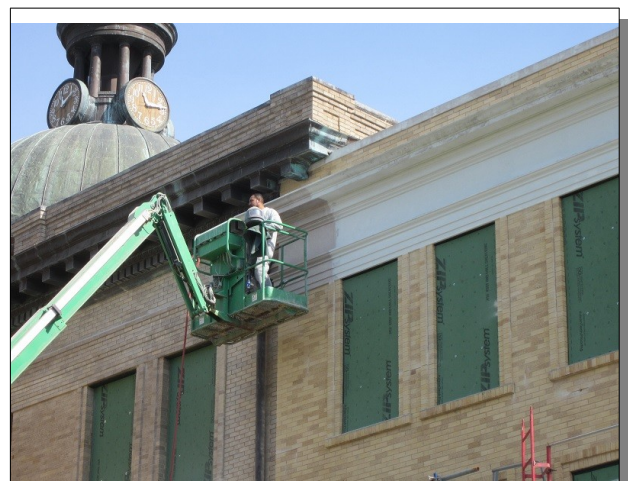
*It was probably painted earlier because it was hard to prevent water penetration and mold. The stone was then sealed.*

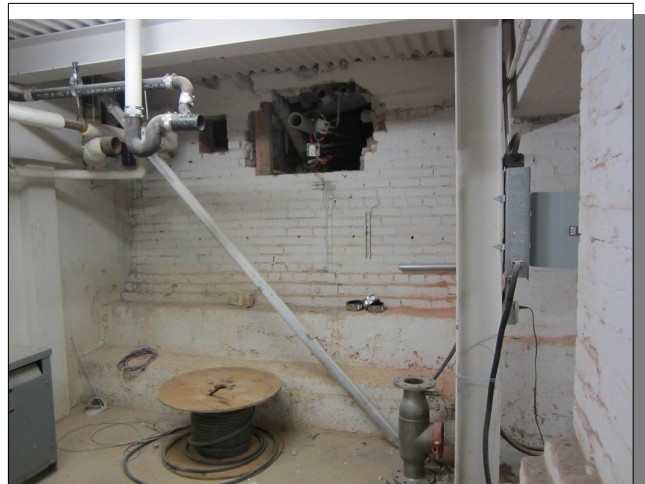
*Basement 2 included a separate bathroom used by blacks beyond where the brick wall was back-filled some time in the past.*

It was dank and damp and records were lost to moisture. That's now all upgraded, as you can tell from being here, we don't have that damp. There's dehumidification that we have installed as well as climate control.
